# Guam Waterworks Authority (VP0989)

## CWA Collection System

Tumon, Guam

NEIC Field Investigation Photographs  
April 24 through May 4

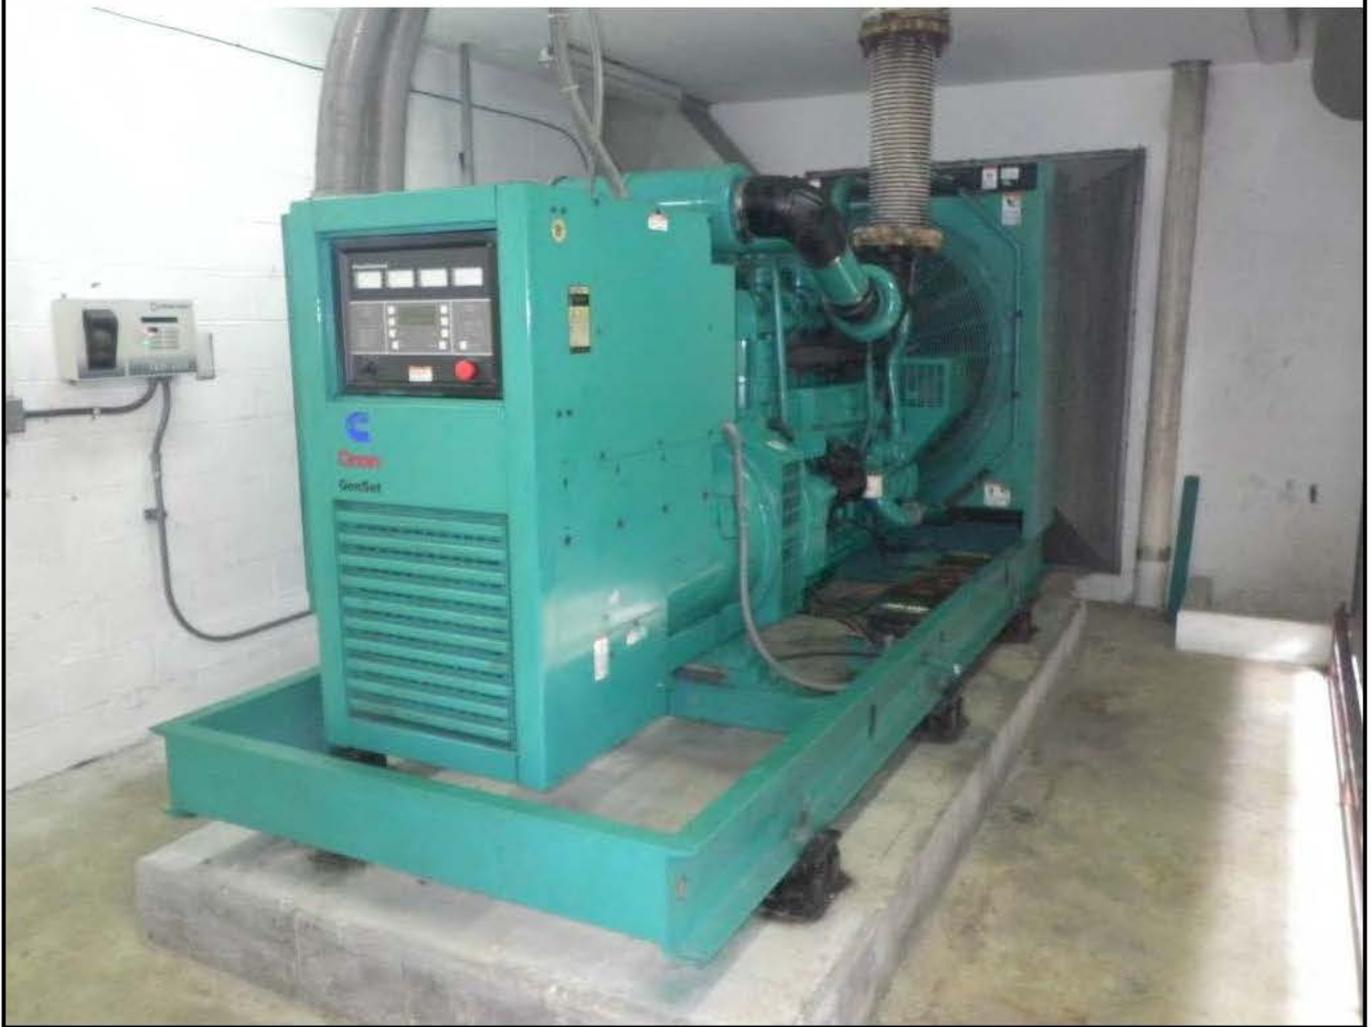
File Name: RIMG0082.JPG

Title	Guam Waterworks Authority (VP0989)
Subject	CWA Collection System
Date Time Stamp	4/30/2012 1:29:06 PM
Photographer	D. Vanlerberghe
Description	New Chaot pump station standby generator

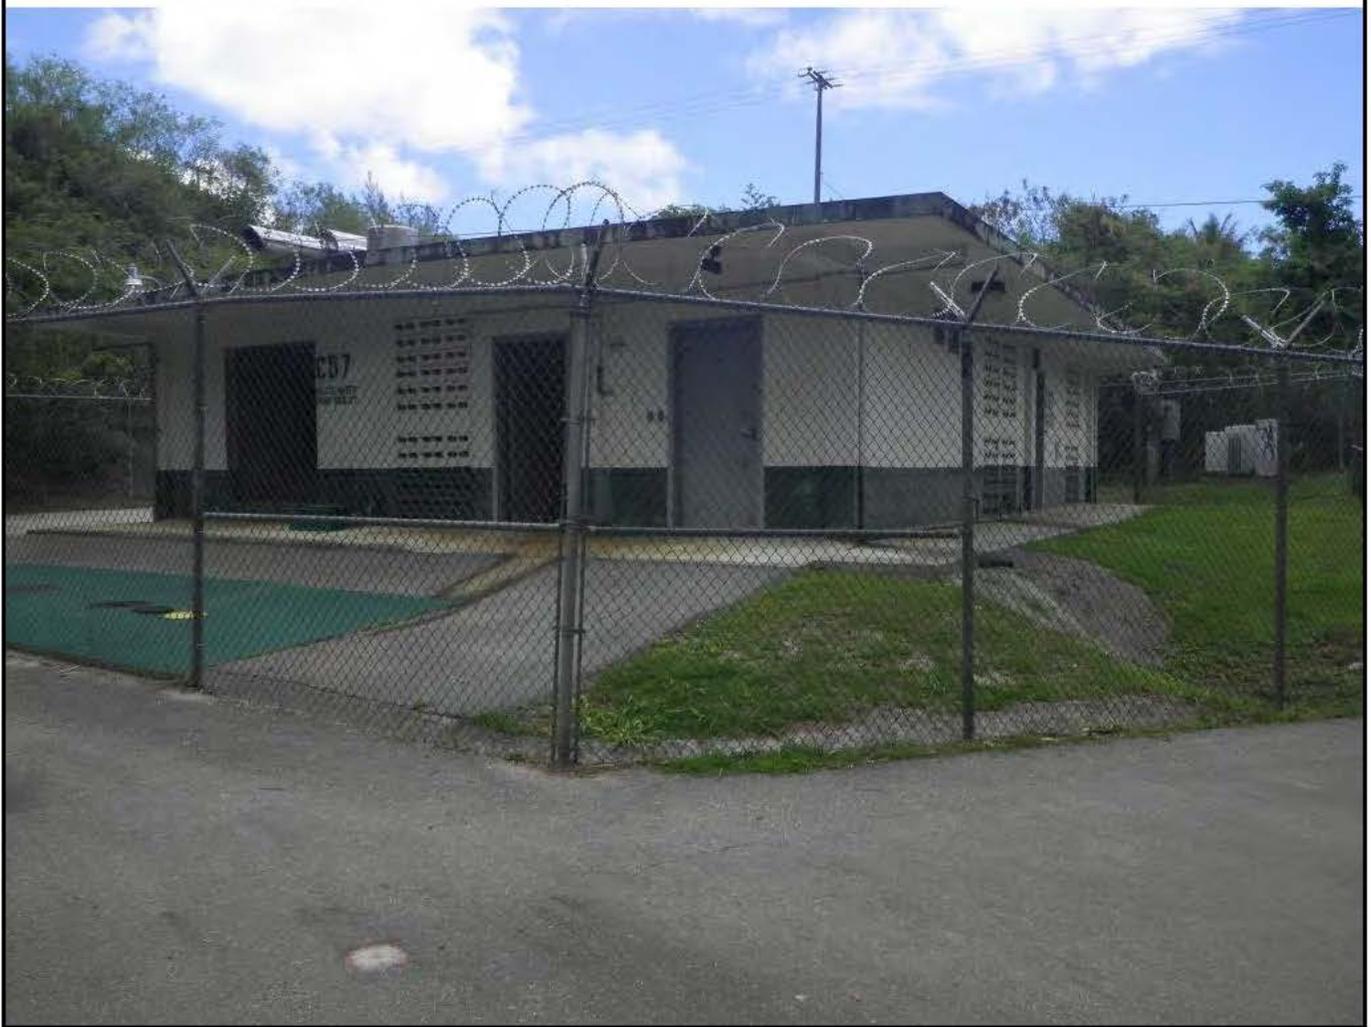
File Name: RIMG0083.JPG

Title	Guam Waterworks Authority (VP0989)
Subject	CWA Collection System
Date Time Stamp	4/30/2012 1:35:13 PM
Photographer	D. Vanlerberghe
Description	New Chaot pump station building.

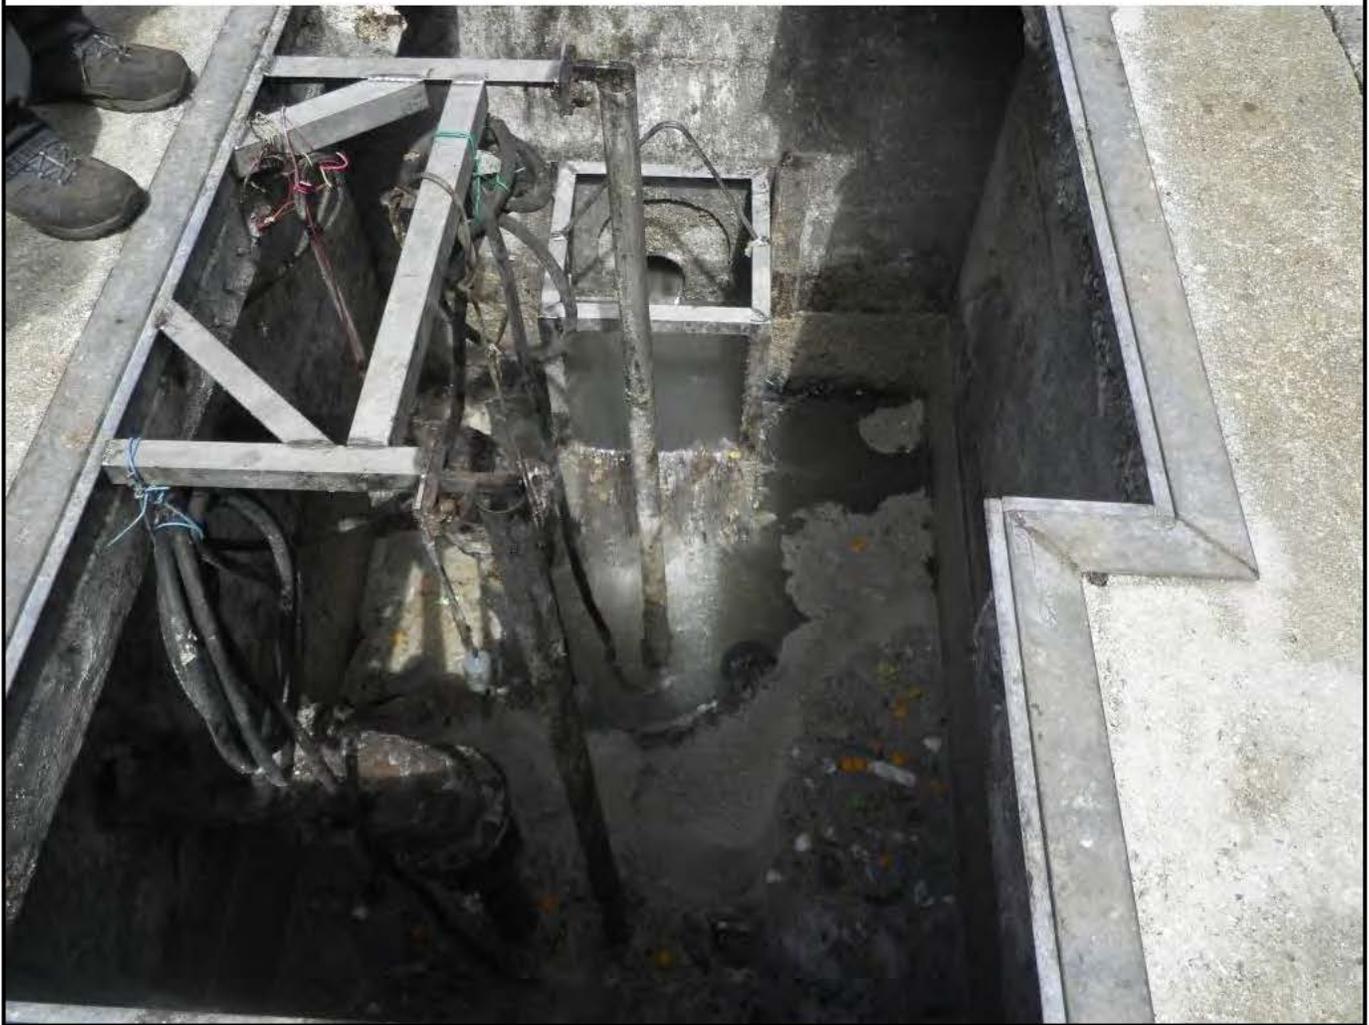
File Name: RIMG0084.JPG

Title	Guam Waterworks Authority (VP0989)
Subject	CWA Collection System
Date Time Stamp	4/30/2012 2:21:00 PM
Photographer	D. Vanlerberghe
Description	Dairy Road pump station wet well.

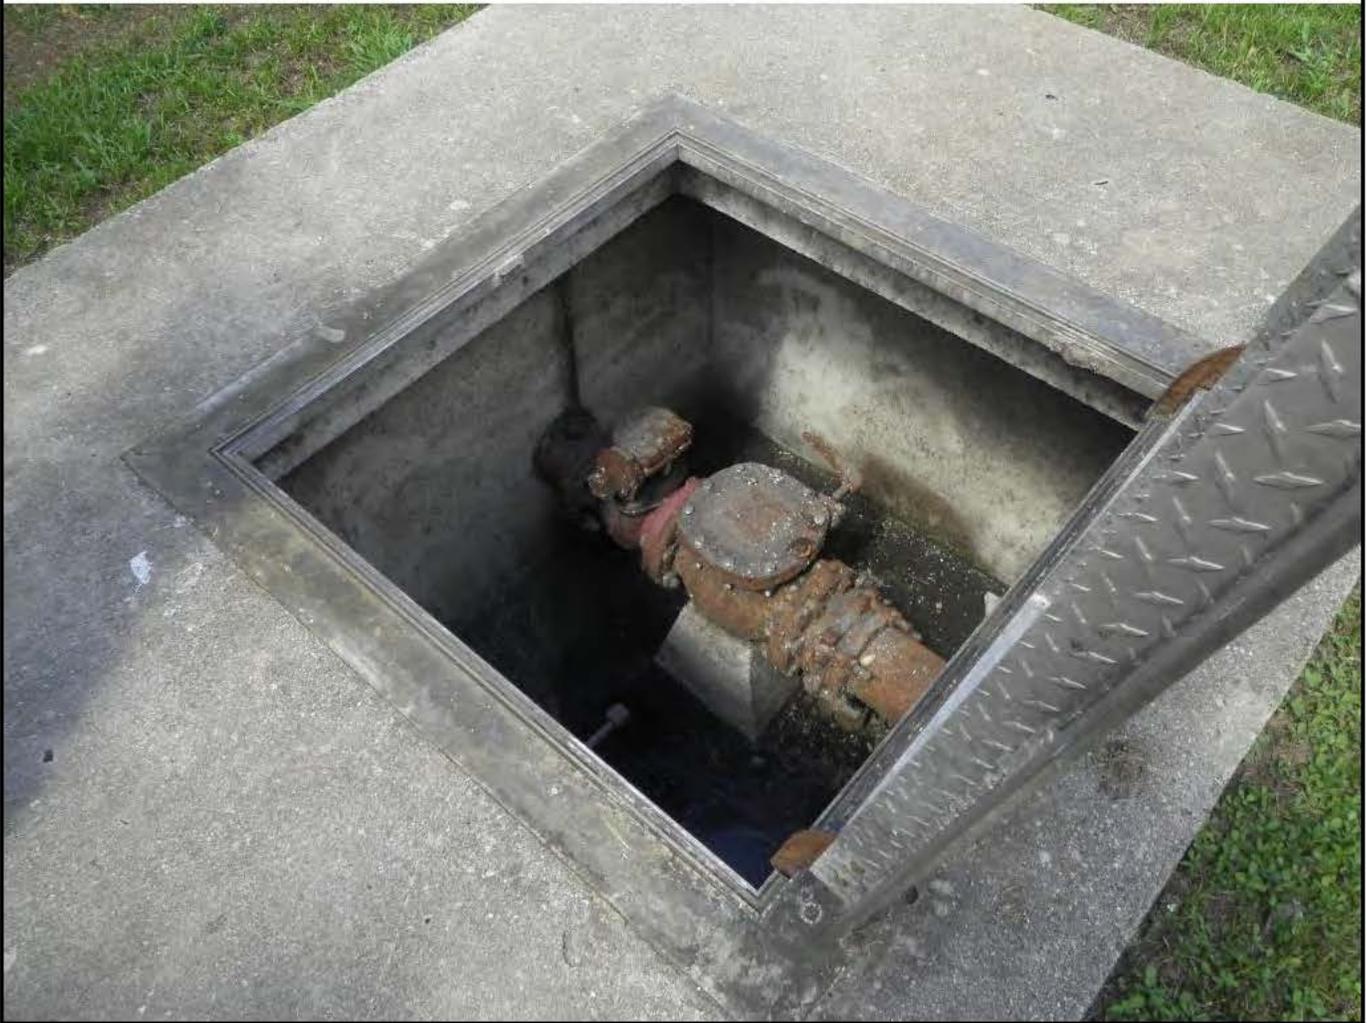
File Name: RIMG0085.JPG

<b>Title</b>	Guam Waterworks Authority (VP0989)
<b>Subject</b>	CWA Collection System
<b>Date Time Stamp</b>	4/30/2012 2:24:43 PM
<b>Photographer</b>	D. Vanlerberghe
<b>Description</b>	Dairy Road pump station check valve.

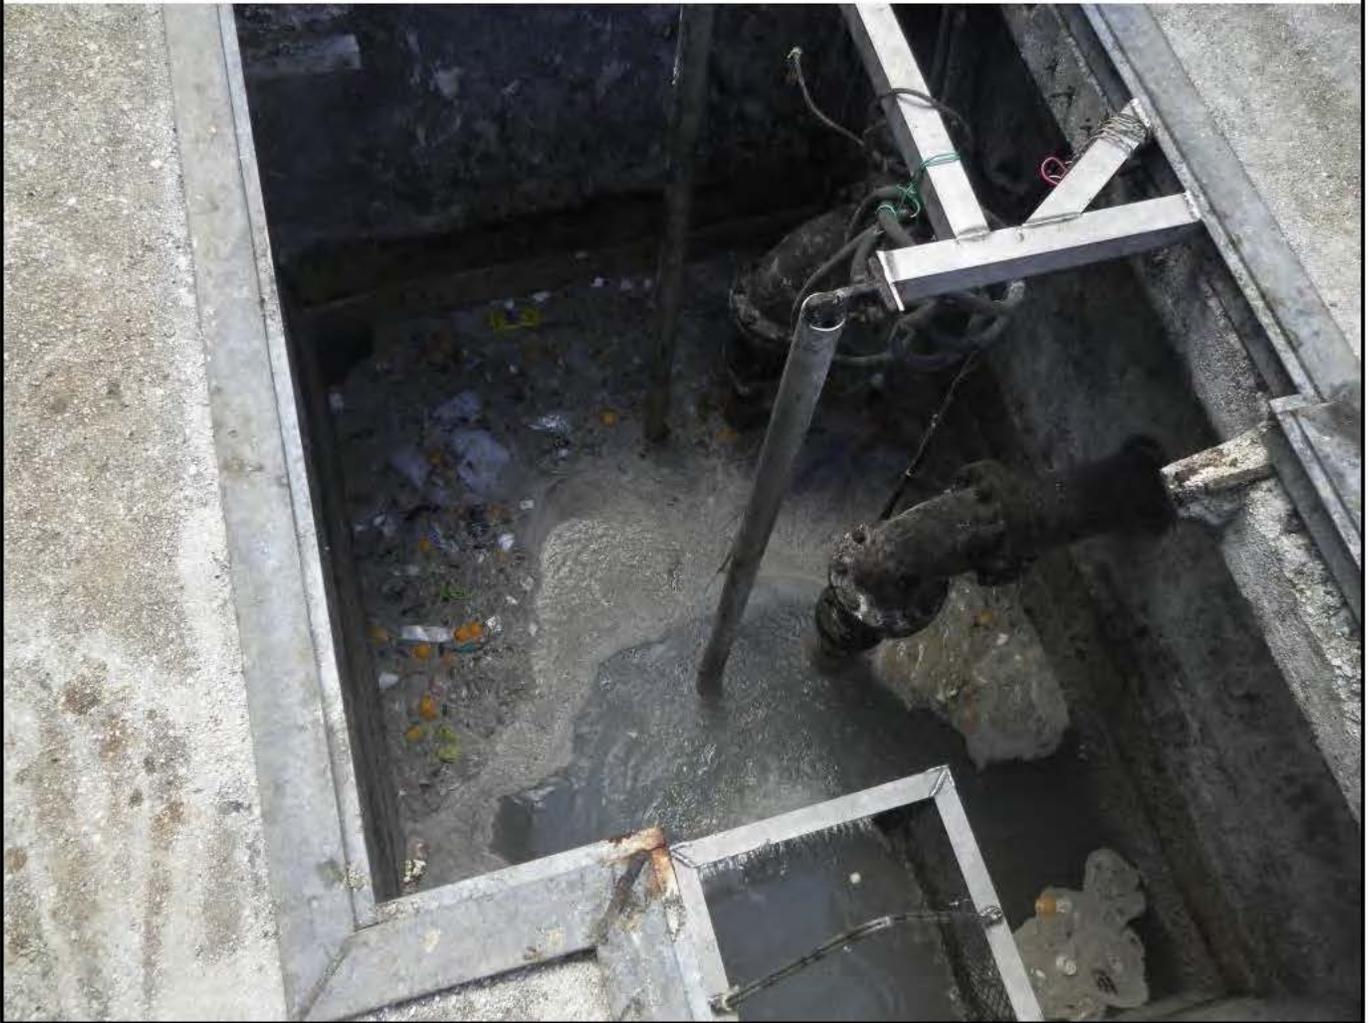
File Name: RIMG0086.JPG

Title	Guam Waterworks Authority (VP0989)
Subject	CWA Collection System
Date Time Stamp	4/30/2012 2:26:15 PM
Photographer	D. Vanlerberghe
Description	Diary Road pump station wet well.

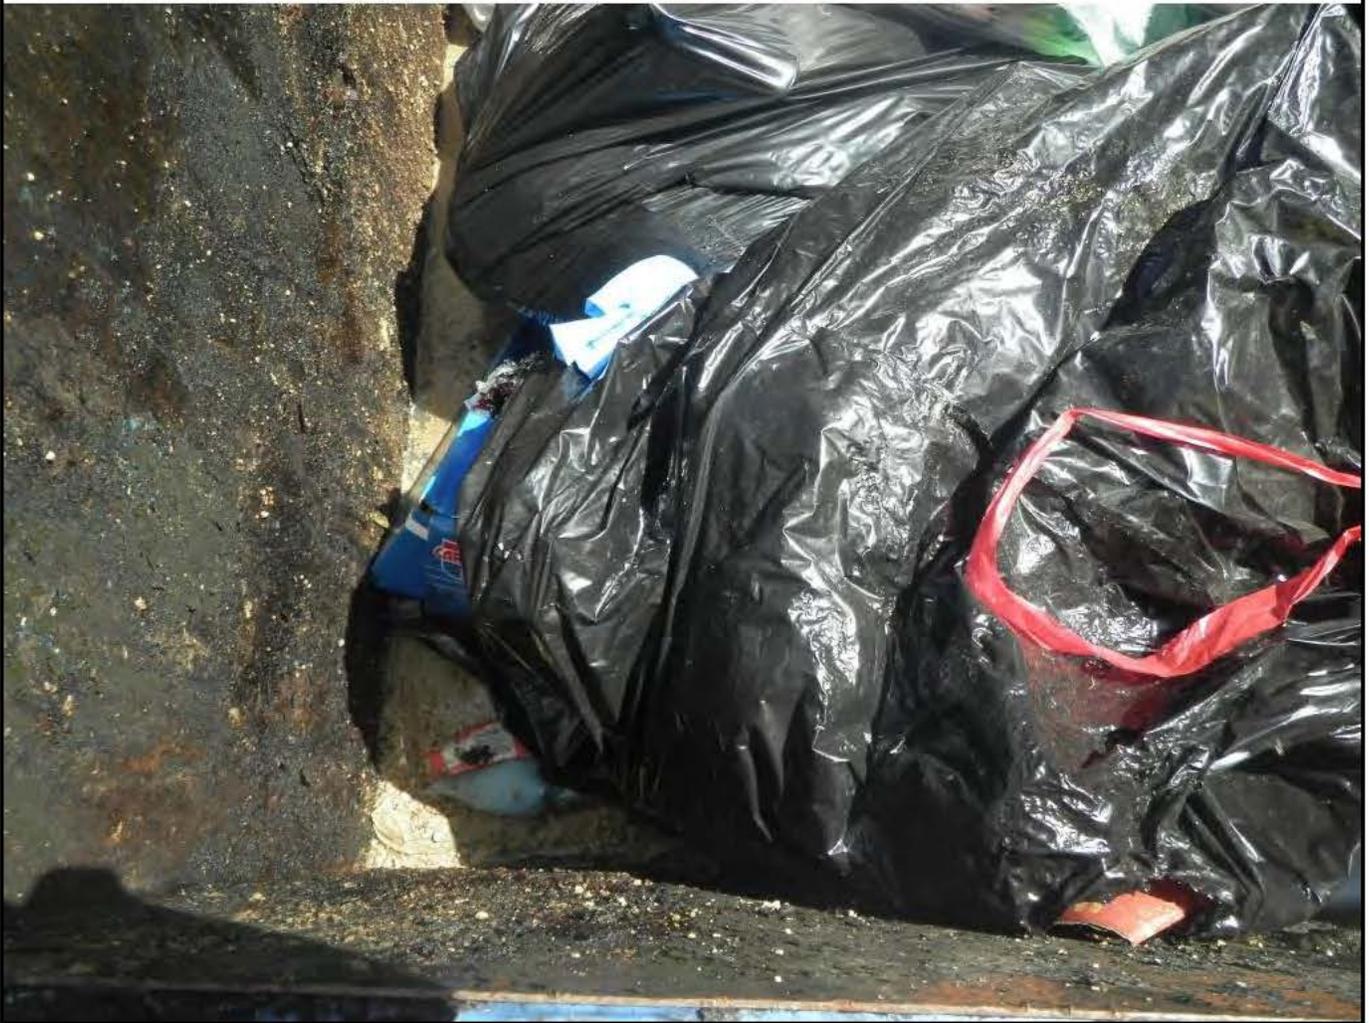
File Name: RIMG0087.JPG

Title	Guam Waterworks Authority (VP0989)
Subject	CWA Collection System
Date Time Stamp	4/30/2012 2:29:03 PM
Photographer	D. Vanlerberghe
Description	Diary Road pump station trash bin for material from bar screen. Trash bin was about half full of grease.

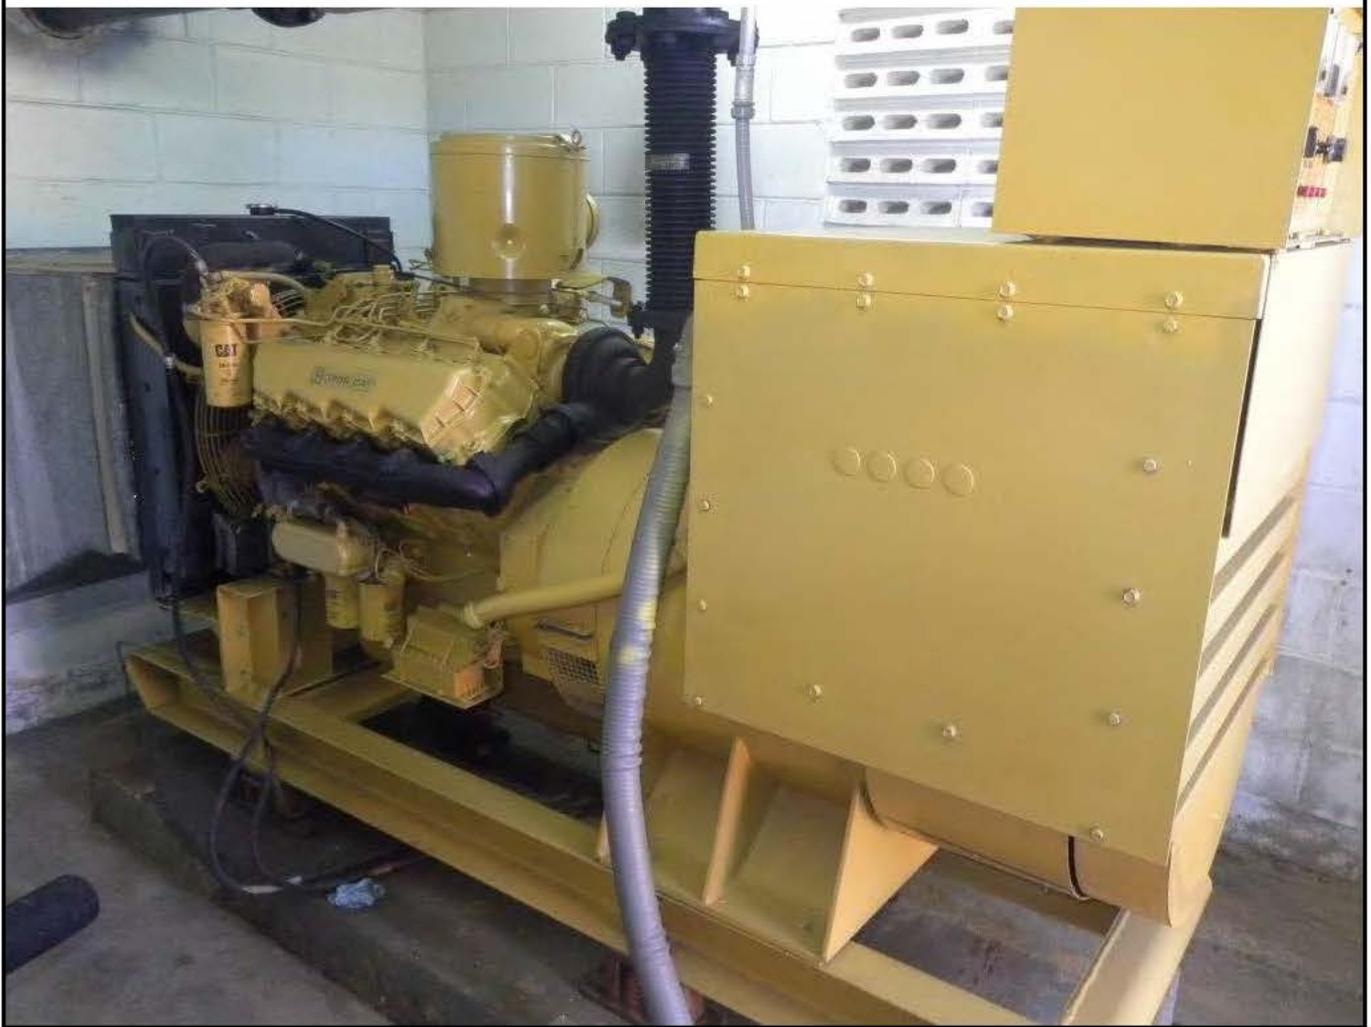
File Name: RIMG0088.JPG

Title	Guam Waterworks Authority (VP0989)
Subject	CWA Collection System
Date Time Stamp	4/30/2012 2:31:18 PM
Photographer	D. Vanlerberghe
Description	Diary Road pump station standby generator.

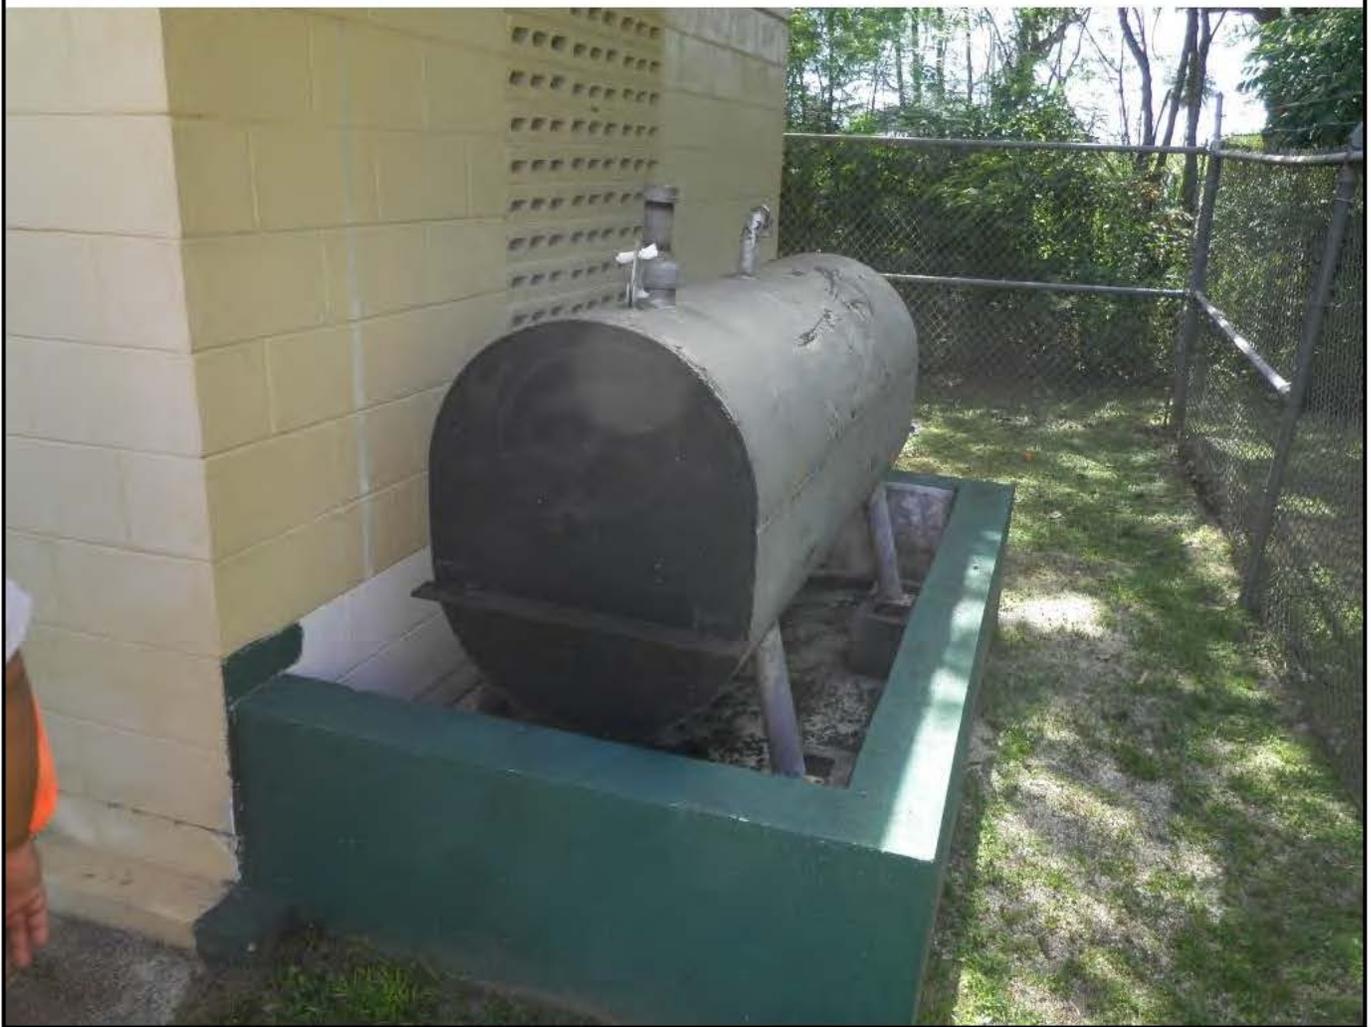
File Name: RIMG0089.JPG

Title	Guam Waterworks Authority (VP0989)
Subject	CWA Collection System
Date Time Stamp	4/30/2012 2:31:59 PM
Photographer	D. Vanlerberghe
Description	Dairy Road pump station diesel fuel tank.

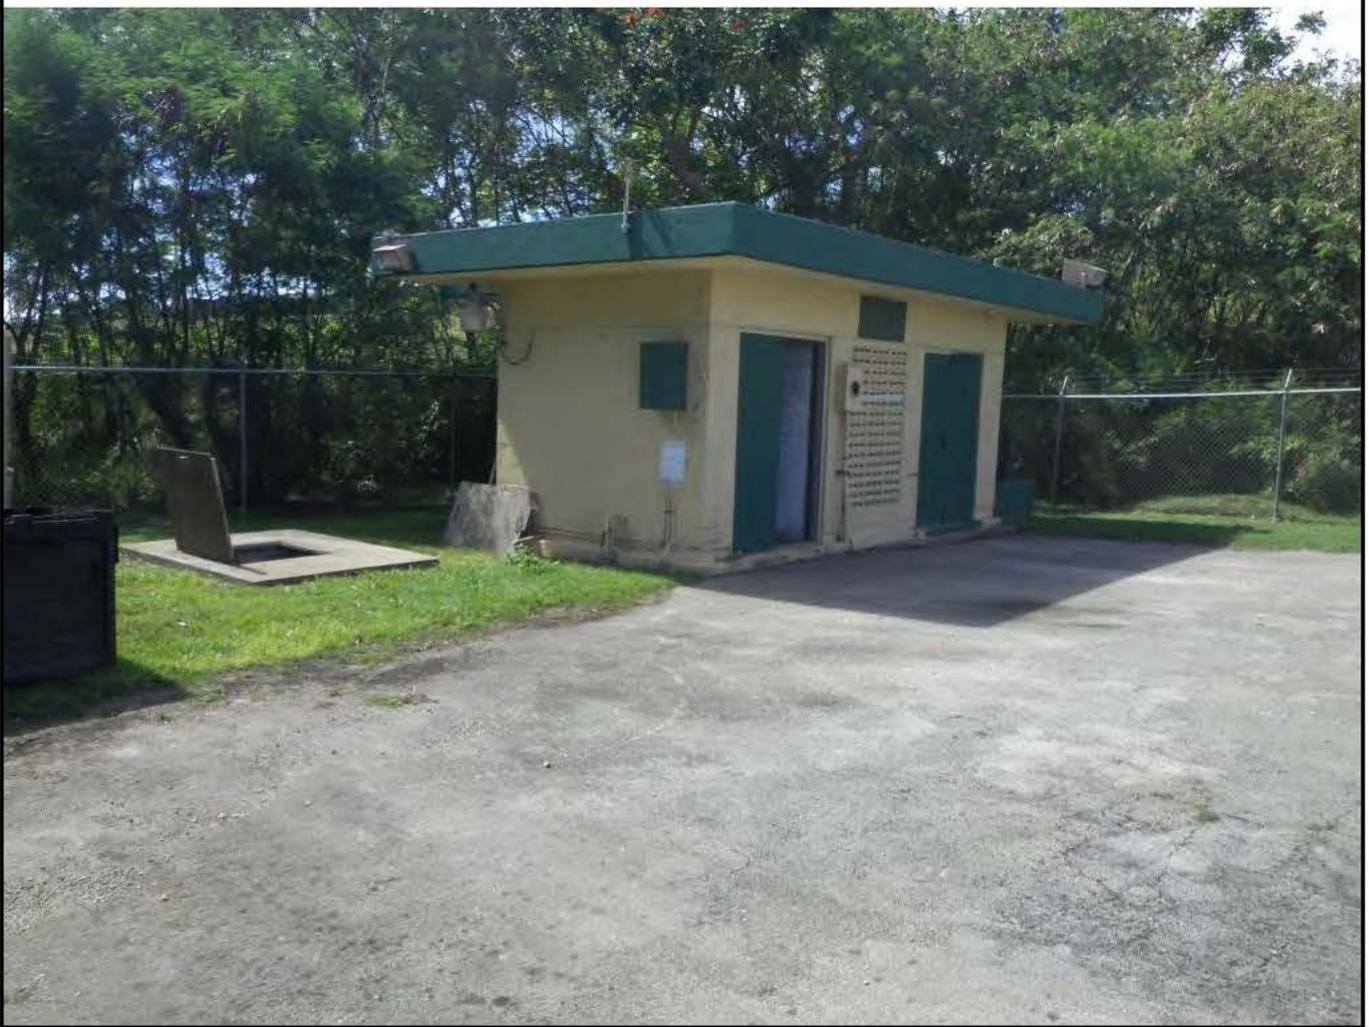
File Name: RIMG0090.JPG

Title	Guam Waterworks Authority (VP0989)
Subject	CWA Collection System
Date Time Stamp	4/30/2012 2:36:59 PM
Photographer	D. Vanlerberghe
Description	Dairy Road pump station building.

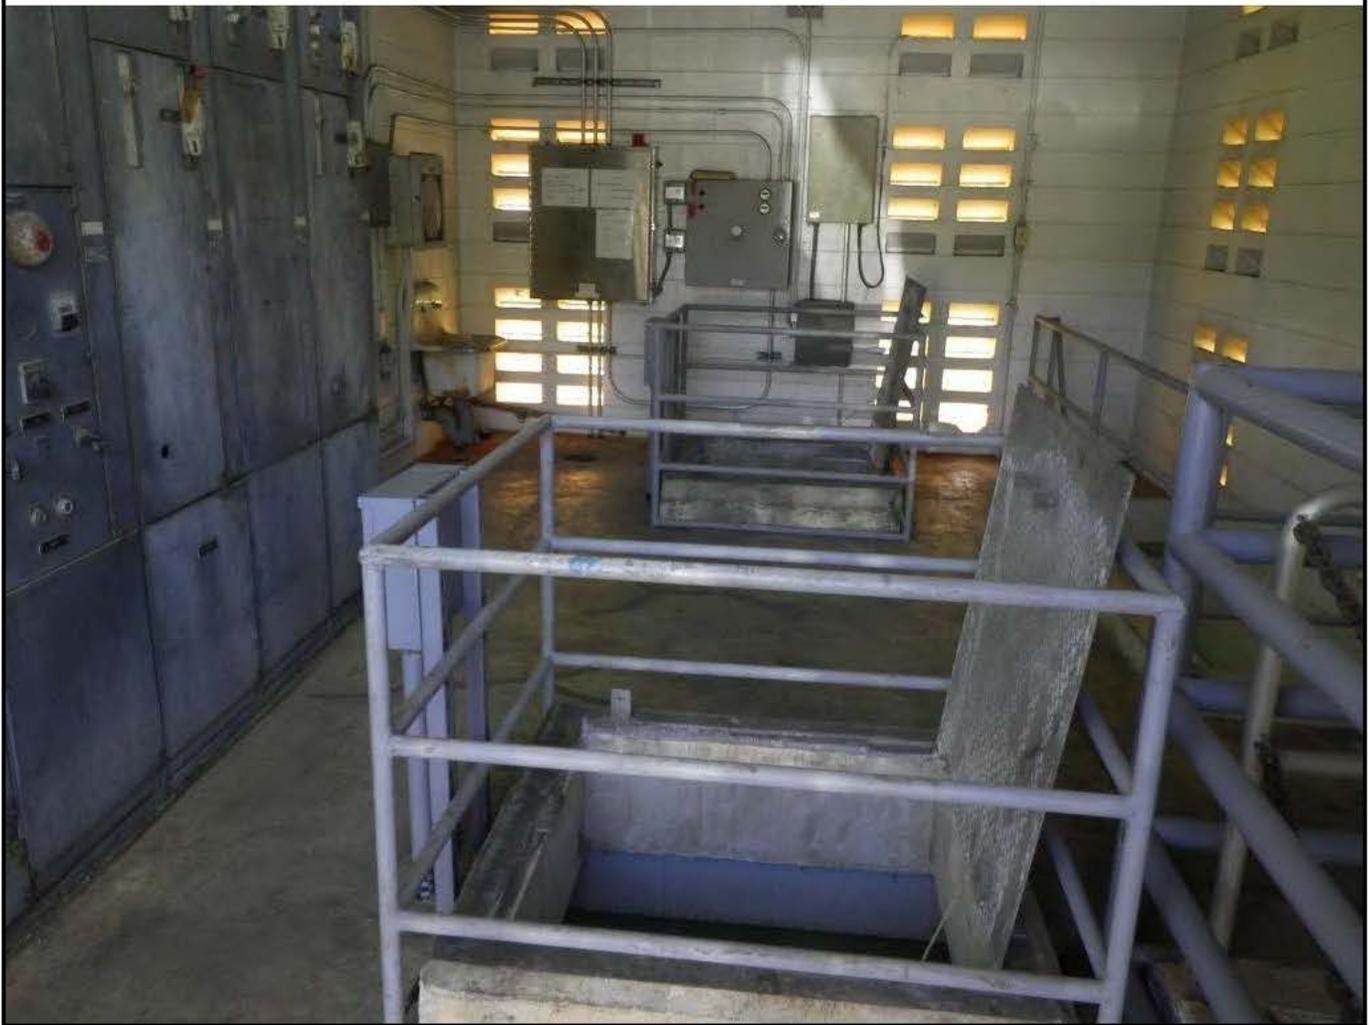
File Name: RIMG0091.JPG

Title	Guam Waterworks Authority (VP0989)
Subject	CWA Collection System
Date Time Stamp	4/30/2012 2:52:31 PM
Photographer	D. Vanlerberghe
Description	Mangilao pump station control room.

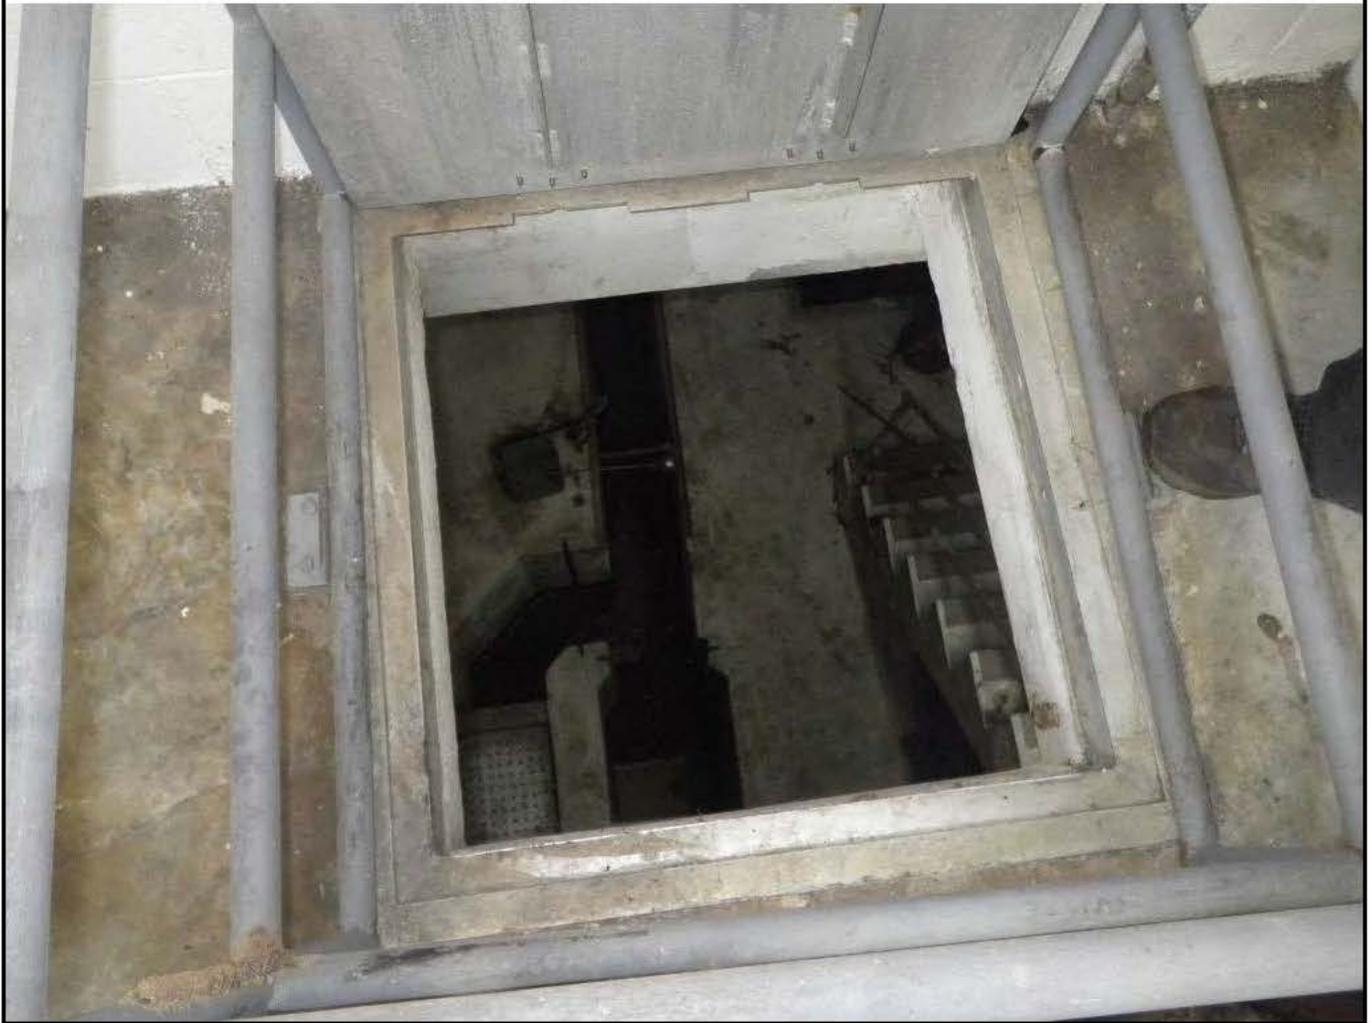
File Name: RIMG0092.JPG

Title	Guam Waterworks Authority (VP0989)
Subject	CWA Collection System
Date Time Stamp	4/30/2012 2:53:25 PM
Photographer	D. Vanlerberghe
Description	Mangilao pump station wet well.

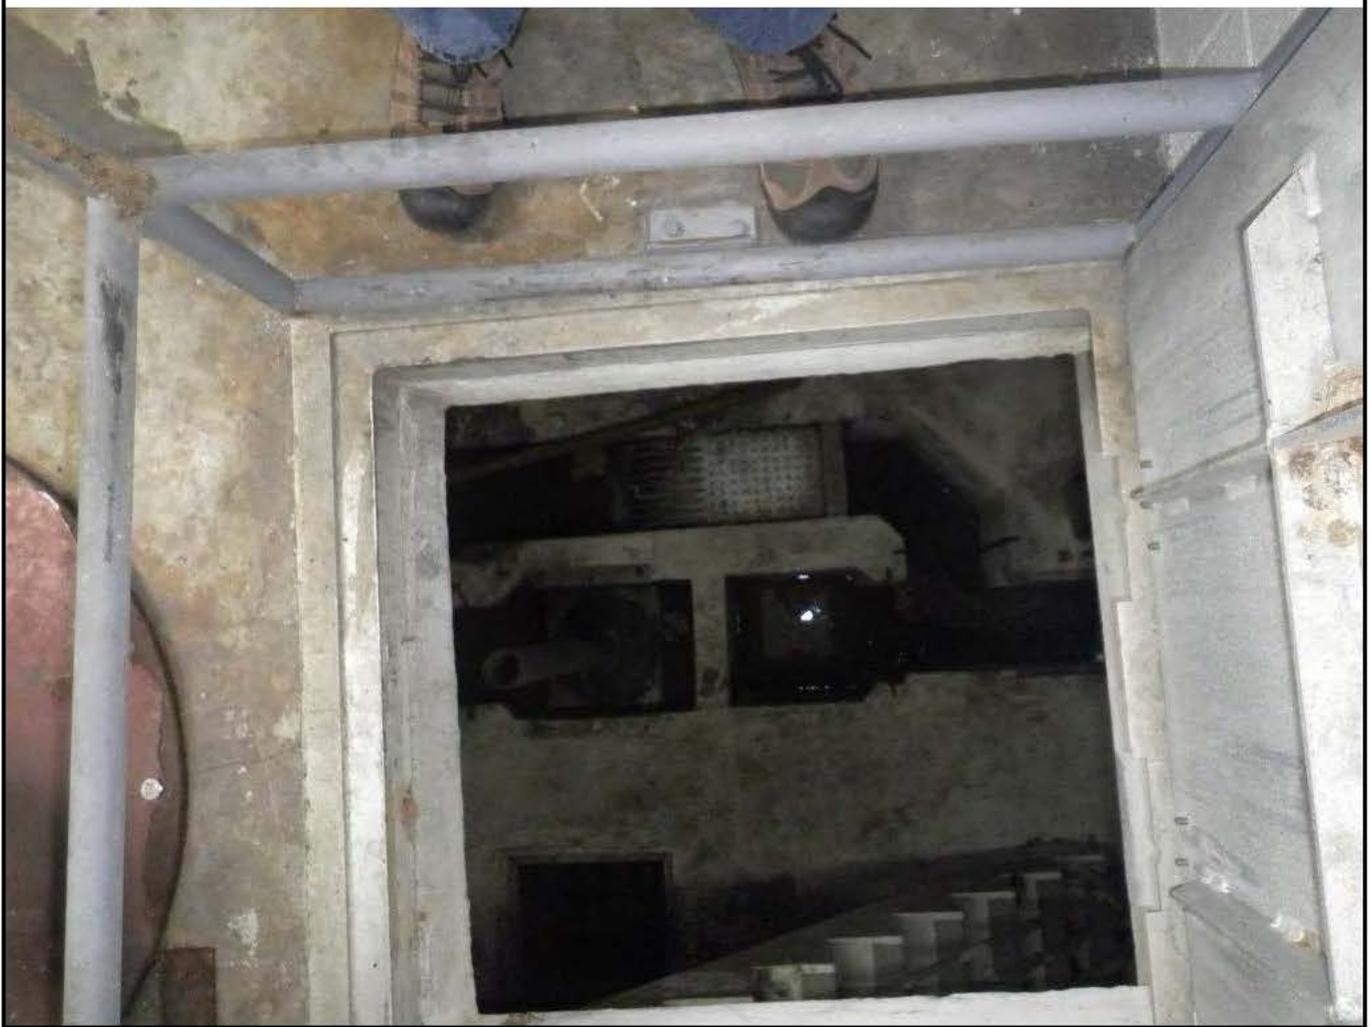
File Name: RIMG0093.JPG

Title	Guam Waterworks Authority (VP0989)
Subject	CWA Collection System
Date Time Stamp	4/30/2012 2:53:45 PM
Photographer	D. Vanlerberghe
Description	Mangilao pump station wet well.

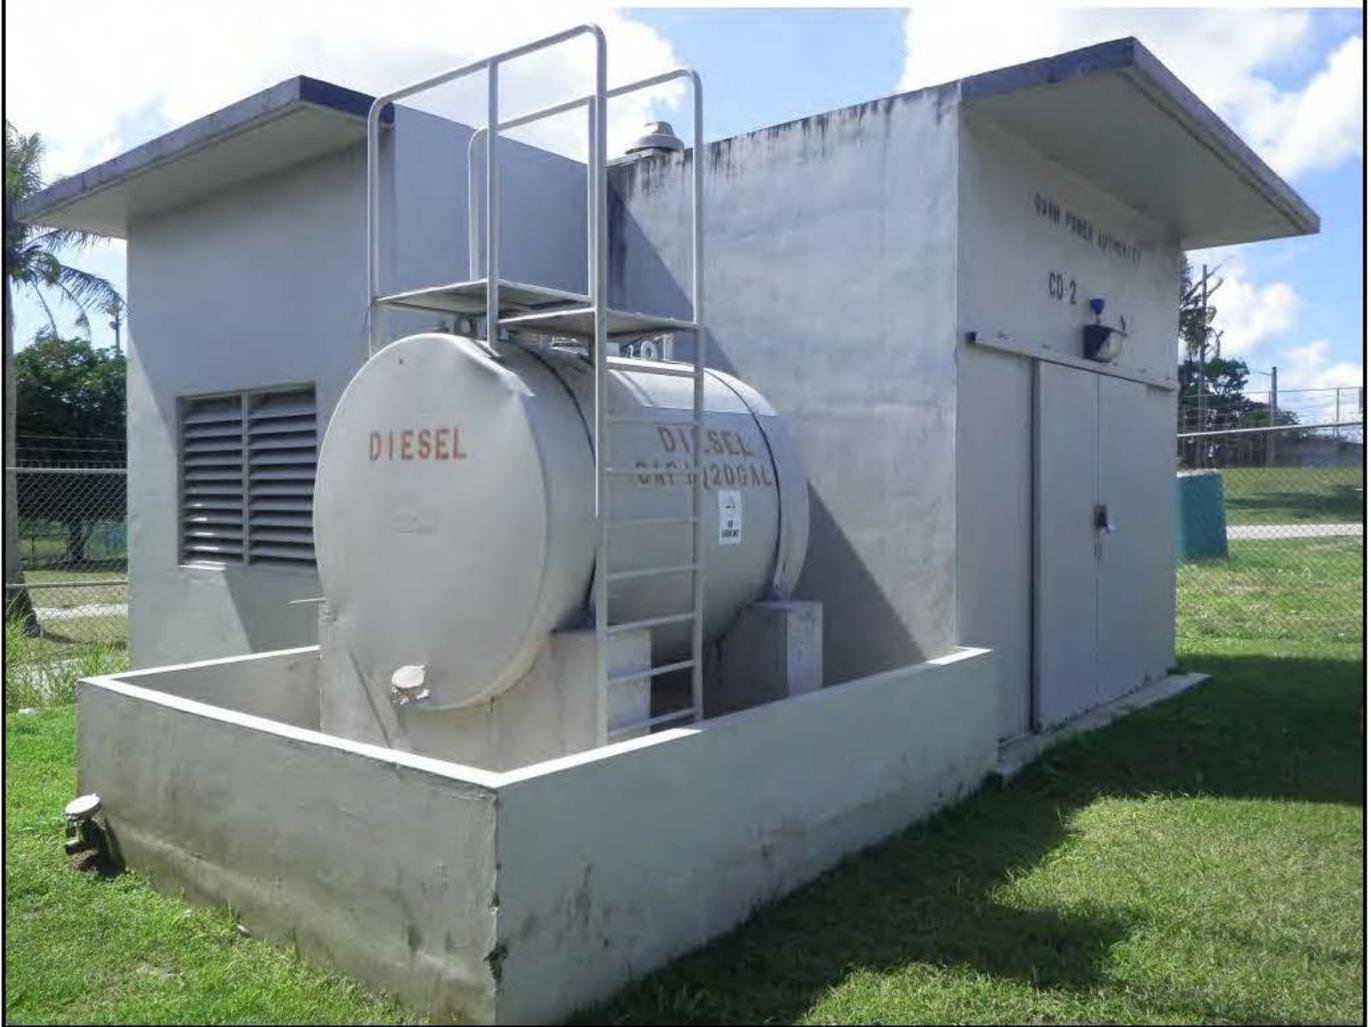
File Name: RIMG0094.JPG

Title	Guam Waterworks Authority (VP0989)
Subject	CWA Collection System
Date Time Stamp	4/30/2012 2:55:02 PM
Photographer	D. Vanlerberghe
Description	Mangilao pump station standby generator.

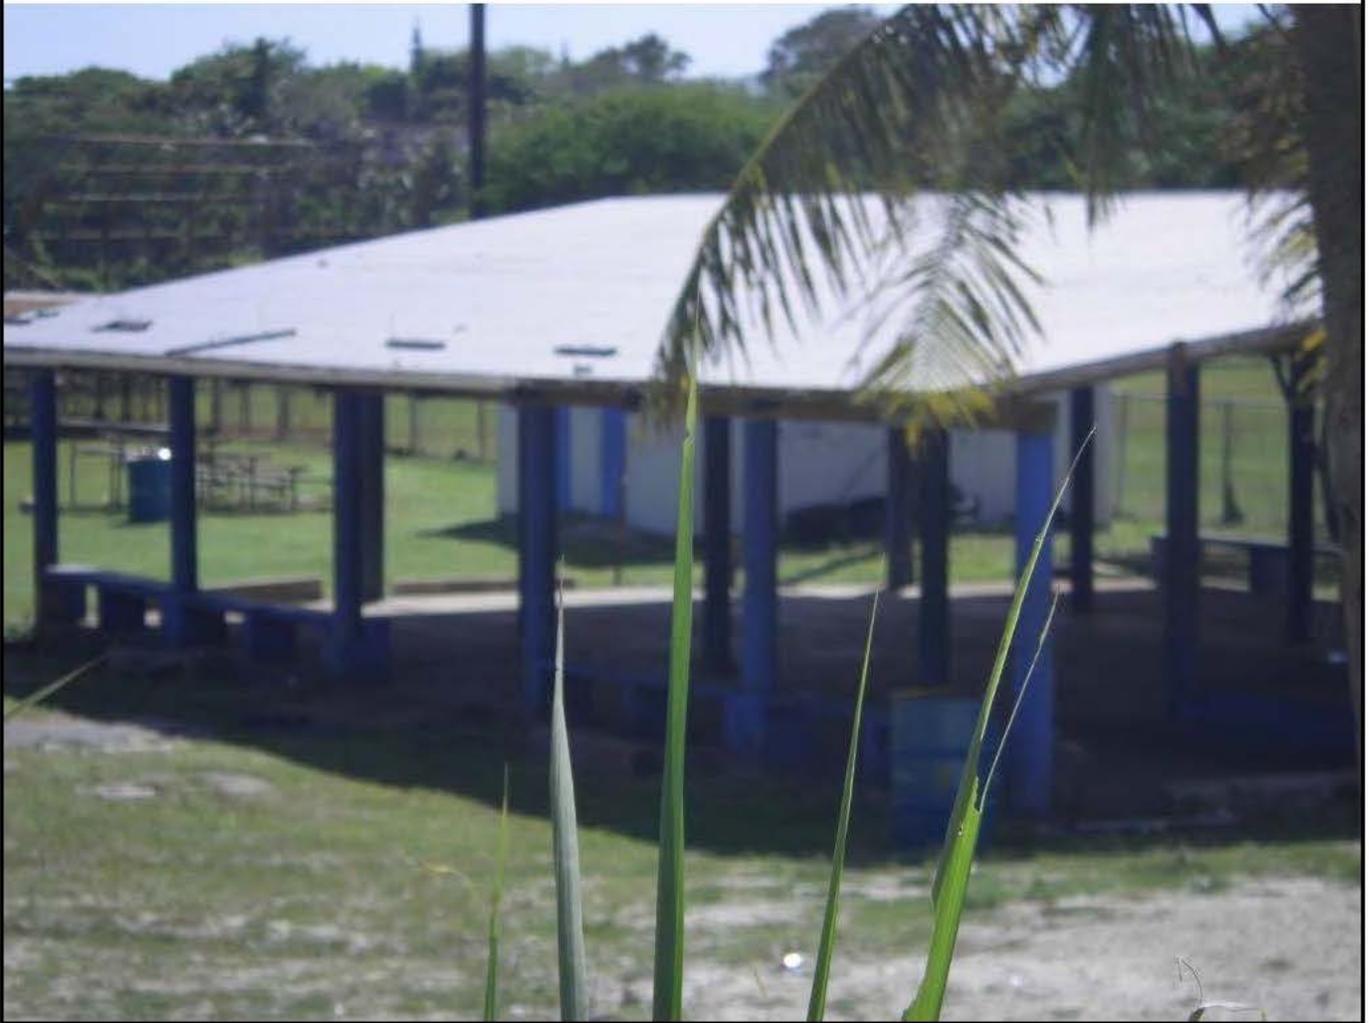
File Name: RIMG0095.JPG

<b>Title</b>	Guam Waterworks Authority (VP0989)
<b>Subject</b>	CWA Collection System
<b>Date Time Stamp</b>	4/30/2012 2:59:03 PM
<b>Photographer</b>	D. Vanlerberghe
<b>Description</b>	Baseball field restroom (behind pavilion), near Mangilao pump station. Overflows occur at restroom due to issues at the pump station.

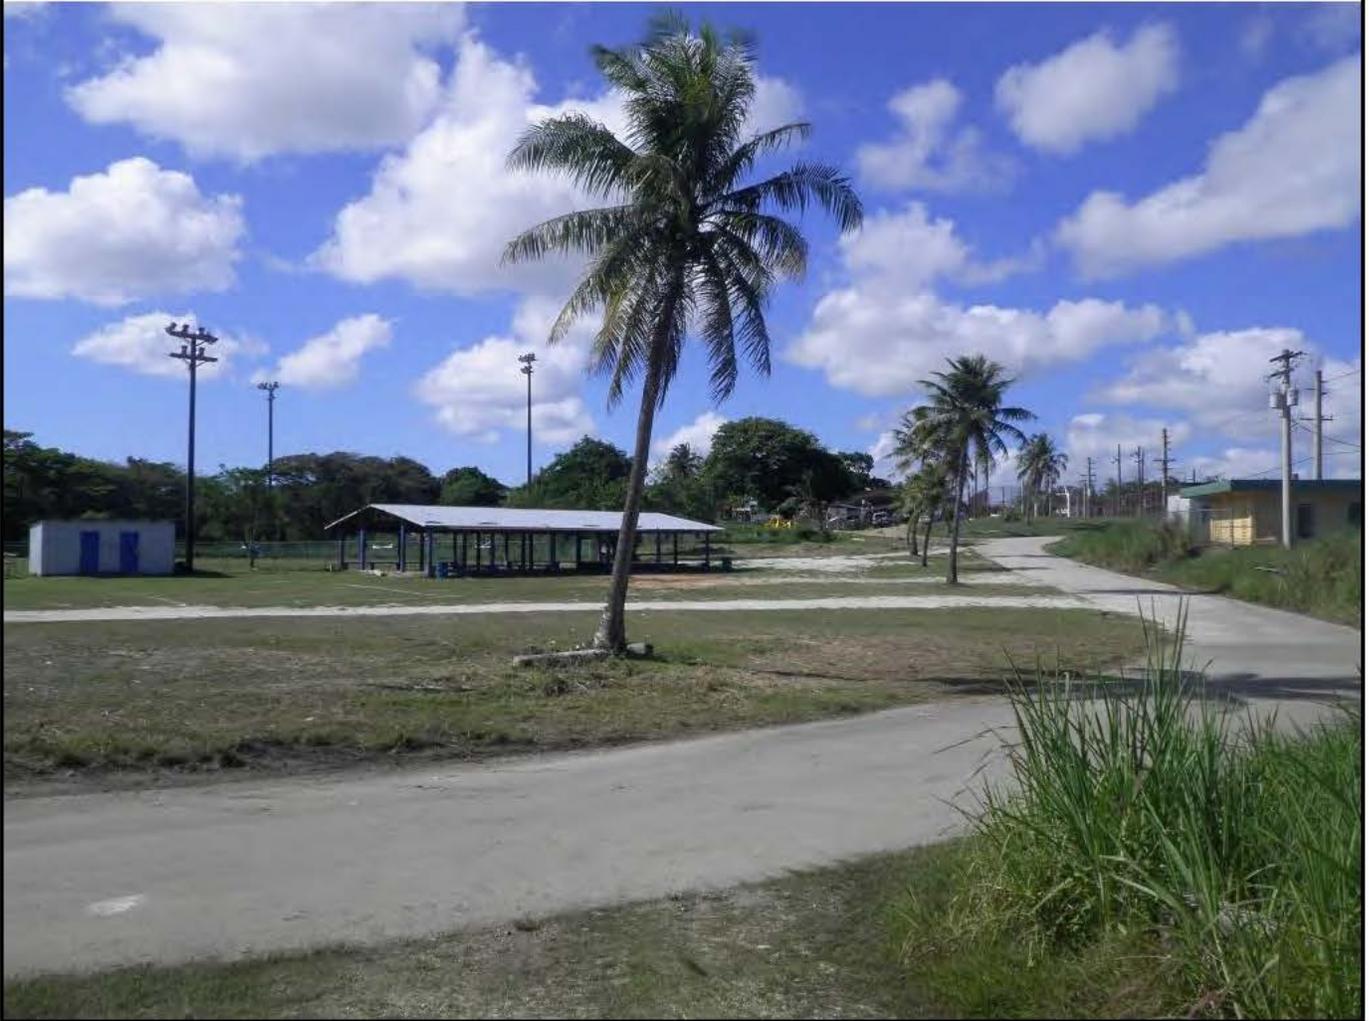
File Name: RIMG0096.JPG

<b>Title</b>	Guam Waterworks Authority (VP0989)
<b>Subject</b>	CWA Collection System
[REDACTED]	[REDACTED]
[REDACTED]	[REDACTED]
<b>Date Time Stamp</b>	4/30/2012 3:28:41 PM
<b>Photographer</b>	D. Vanlerberghe
<b>Description</b>	Mangilao pump station (on right) and baseball field restroom (on left). Overflows occur at restroom due to issues at the pump station.
